# **FUEL SYSTEM DURABILITY— U.S. COAST GUARD**

**INTERIM REPORT  
TFLRF No. 393**

**U.S. Army TARDEC Fuels and Lubricants Research Facility  
Southwest Research Institute® (SwRI®)  
San Antonio, TX**

**Contract No. DAAE-07-99-C-L053 (WD20)  
SwRI Project No. 08.03227.20.001**

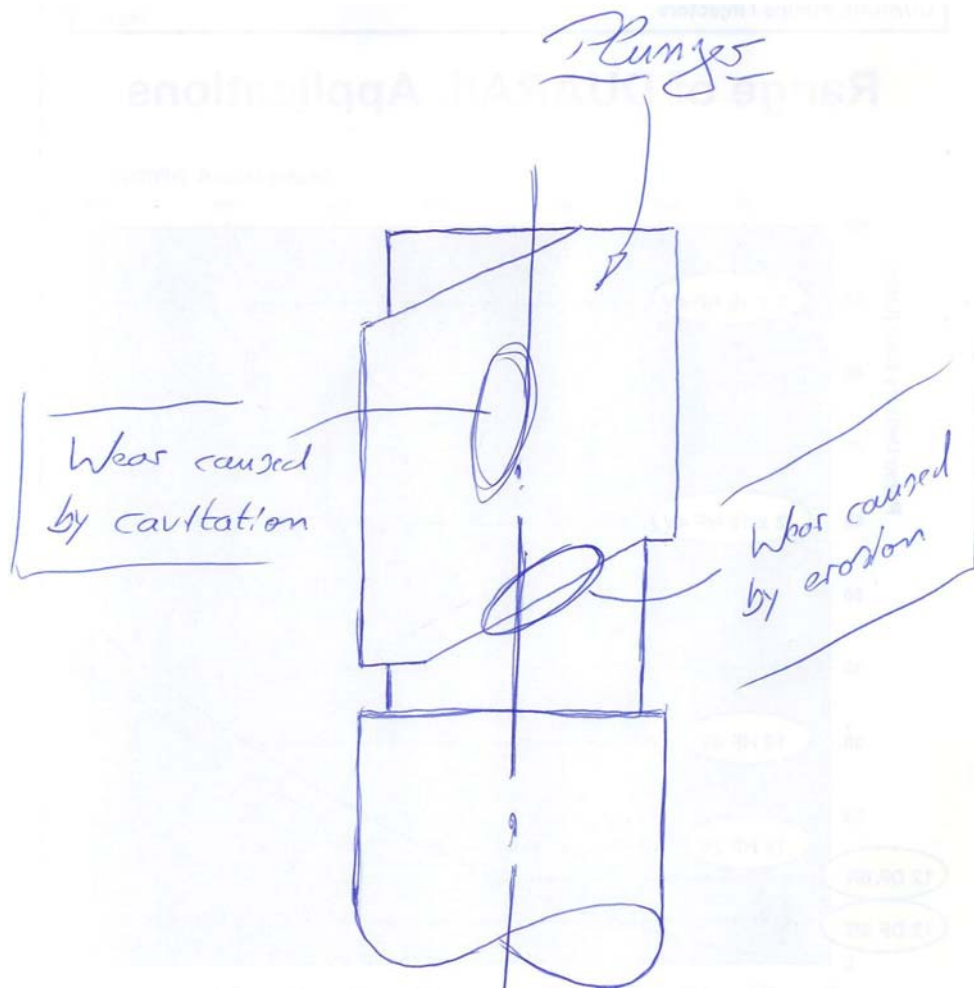
**Figure 10. Sketch from DUAP on Plunger Wear Areas**

In addition, ANS Technologies had agreed to perform a trial activation at their cost to validate the equipment setup, masking scheme and production rate. SwRI had sent the spare Sulzer plunger to ANS for this activation. The plunger manufacturer DUAP supplied a sketch (Figure 10) of two characteristic wear areas on the fuel injection pump plunger. One wear area was at mid-stroke on the plunger most likely where maximum fuel injection pressure is developed. ANS made a tantalum mask for the plunger in the area designated by SwRI for the trial activation. The activation was performed and the preliminary results indicated the masking and production rates were satisfactory.

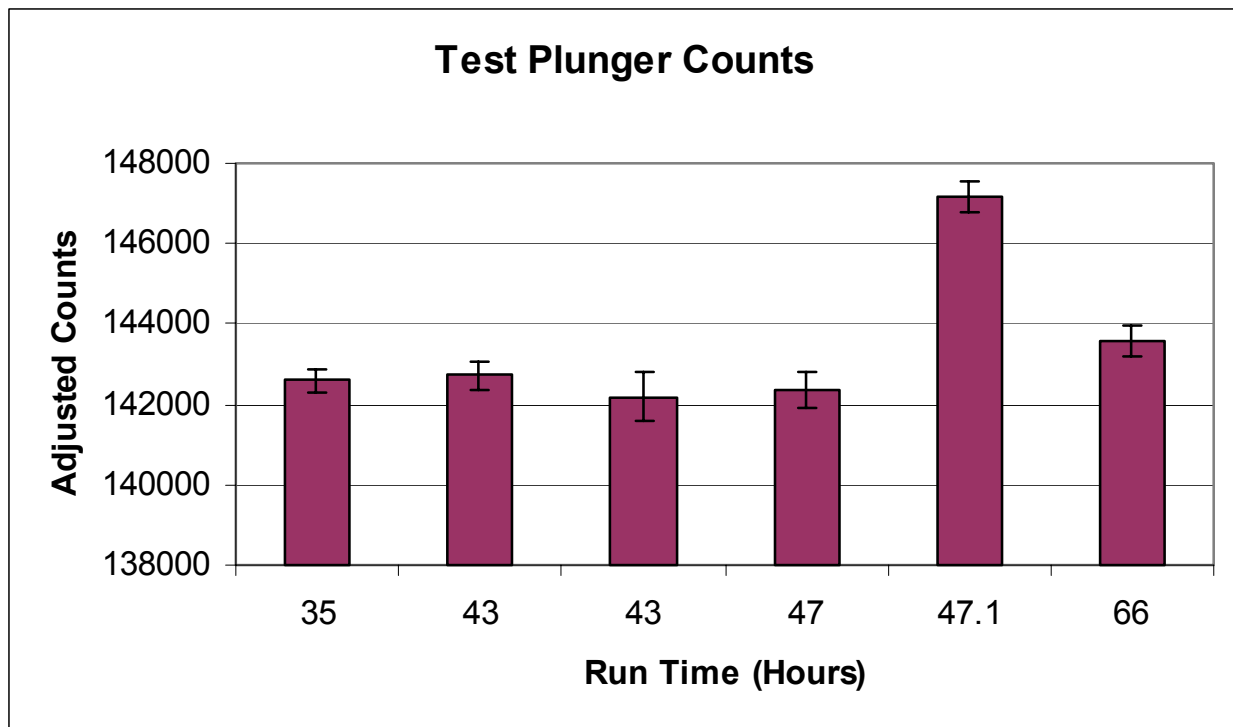
**Figure 15. Plunger Activity Adjusted for Half-Life**

possible, this was an indication that SwRI was still experiencing a detector stability problem. A decrease in activity was recorded between running hours 47 and 66 on the plunger, however due to detector instability, this data is not statistically reliable. This data is shown in Figure 15, with counts adjusted for isotope half-life.

SwRI suspected there was still a magnetic field effect, which caused fluctuation of the detector readings during in-situ plunger activity measurements. SwRI re-measured the 66-hour data point after a five-day delay and the measurement was statistically the same. The flywheel was then rotated five degrees and the plunger was re-measured. SwRI believes that this rotation was within the dwell location of the plunger, so the plunger should not have moved vertically or rotationally because the rack was fixed. A significant drop in counts was detected. SwRI suspects this may be due to a change in the magnetic field position of the flywheel. SwRI has confirmed the magnetic field effect with the NaI detector. The investigation into the fabrication of a mu-

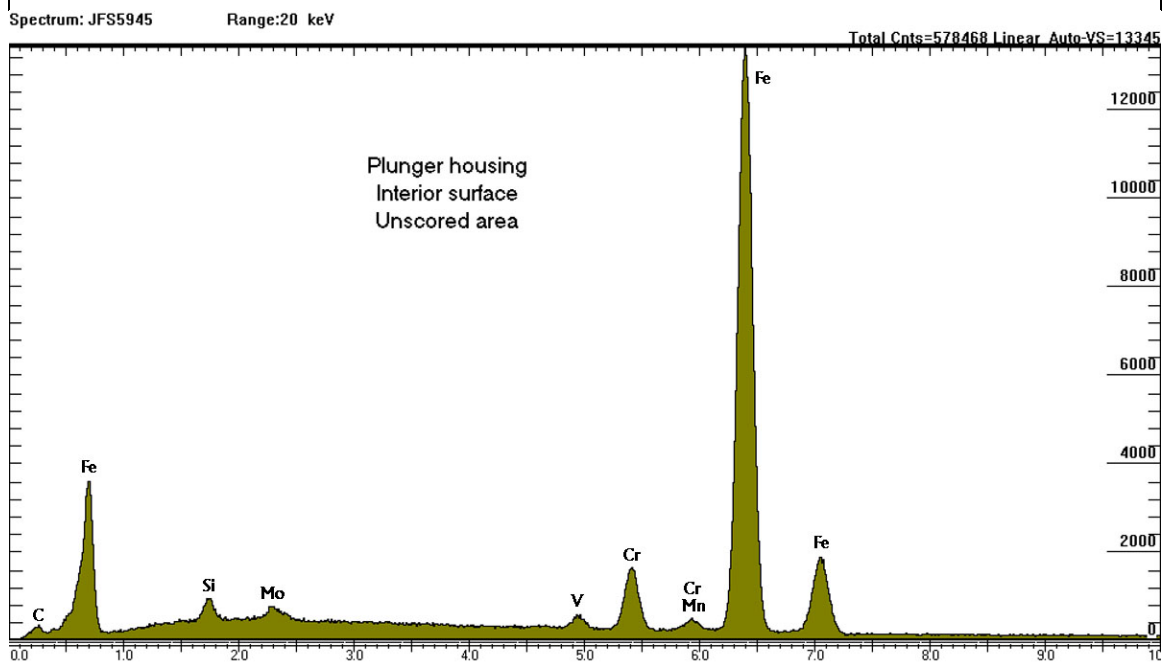
Figure 30. Elemental Scan Results for Unscored Area of Barrel

An elemental analysis was performed on an area of the barrel that did not reveal wear and on one of the scored areas. The un-scored area elemental results matched closely with the base metal elemental results. Figure 30 details the elemental analysis of the scored area and Figure 31 details the elements found in a scored area of the barrel. An element that shows up in the scored area is aluminum, which does not show up in the base metal or unscored area elemental scans. The quantity of aluminum is small, thus alloying elements are not seen so it is not certain if the aluminum is from an alloy or from an abrasive such as aluminum oxide.

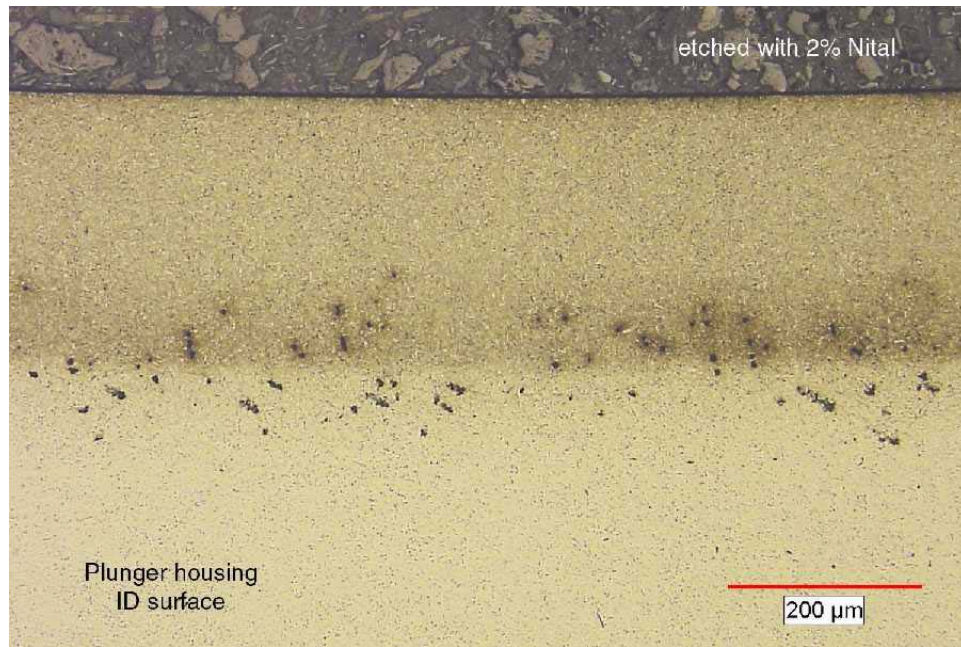
**Figure 32. Barrel Etched to Determine Case Hardness Depth**

The heat treatment case depth was checked for the barrel. Figure 32 shows the etched barrel section with the depth of the case hardening around 300-microns.

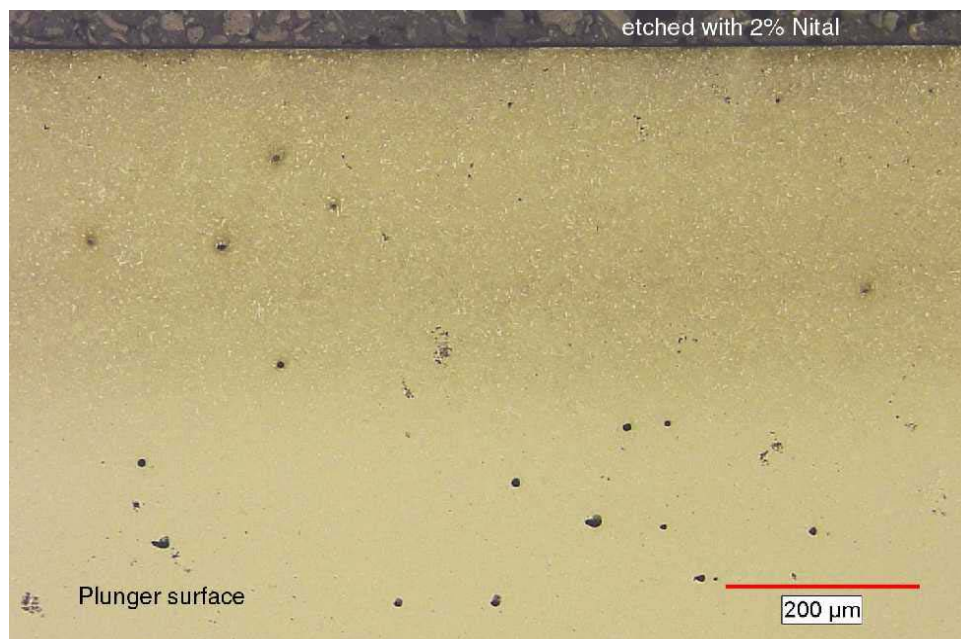
**Figure 38. Case Depth of the Fuel Injection Plunger**

The damaged plunger was also examined. Figure 34 shows a damaged section of the plunger that was examined. The SED image of a worn area of the plunger is shown in Figure 35. Evident in the figure is vertical and circumferential fracture lines. Figure 36 also shows circumferential fracture lines evident on the plunger surface as highlighted by back scatter imaging. A magnified image of the cracking is highlighted by backscatter imaging in Figure 37. On the cracking, plastic deformation of the hardened surface layer appears to be causing cracks that propagate parallel to the surface and cause small pieces to eventually spall off. The depth of the carburized case is around 300 micron as shown in Figure 38. An undamaged area of the plunger is shown in Figure 39. The core and surface hardness of the plunger were found to be Rc 34 for the plunger core hardness and Rc 56 for the surface hardness.

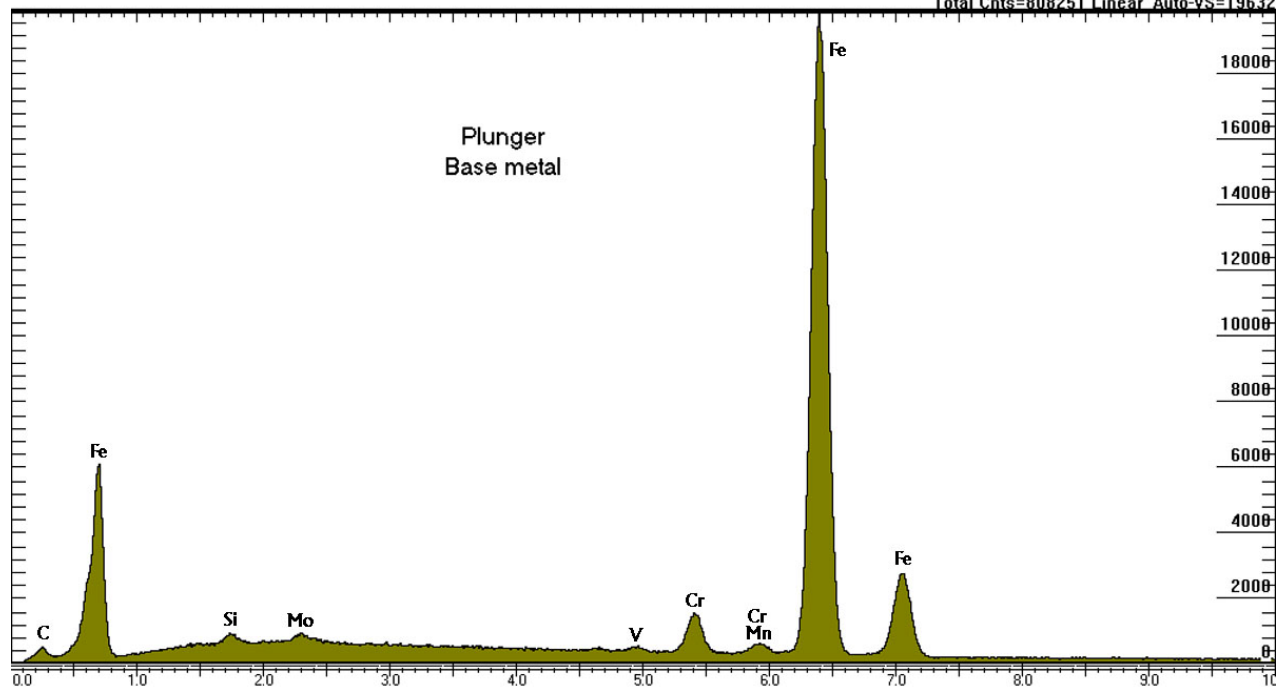
Figure 41. Elemental Scan of Plunger Base Material

Elemental scans were performed on the base material and on a damaged section of the plunger to determine if foreign materials were present in the wear scars. As seen with the barrel, the plunger revealed a small aluminum peak in the damaged areas as shown in Figure 40. The undamaged area did not show an aluminum peak as seen in Figure 41.

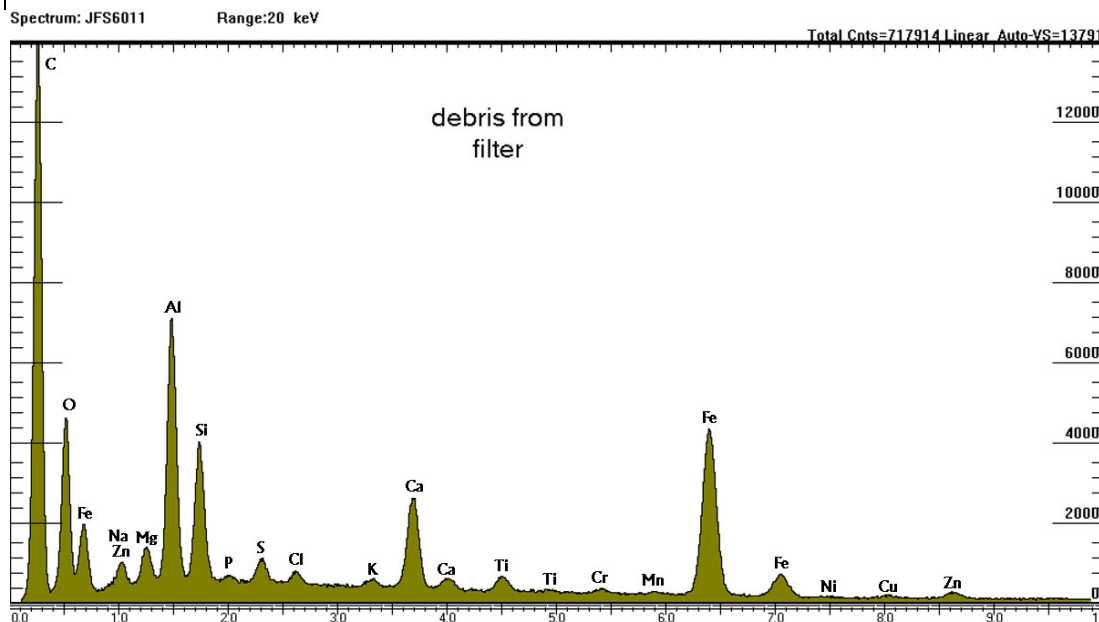
Figure 42. Fuel Filter Debris Elemental Analysis

The system fuel filter was washed with a solvent, then the solvent was filtered through a Millipore filter, then the filter was dried. The remaining debris was analyzed for elemental composition and the results are shown in Figure 42. Particles of iron and aluminum alloy were found in the filter debris as shown in Figure 43. The aluminum may have come from the threads of the filter element holder when it was tightened after the filter was changed. The iron could be wear debris that is recirculating through the fuel injection system. It is known that particulate can be pumped through filter media due to pressure pulsations. The pressure pulsations for the single pumping element system were quite severe.
